# UTAH STATE CAPITOL ARCHITECTURE: INTERIOR IMPACT ZONE SURVEY REPORT

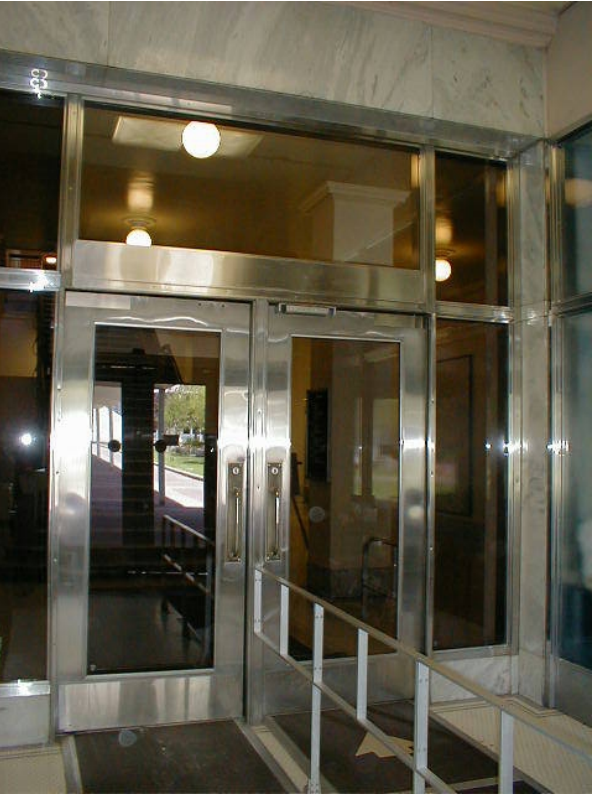
## 100vn North Vestibule 1st Floor

Element	Description	Historical Significance	Notes
ST-7	Metal post, painted	Significant Qty:	
E-6	Paging intercom w/ switch	Non Contributory Qty:	
E-1	Camera, mounted in wall	Non Contributory Qty:	
BA-06	Plastered beam, with chamfered ends, first floor corridor	Very Significant Qty:	
F-2	Tile floor, hex & square, mosaic	Significant Qty:	
CL-04	Plaster ceiling, smooth, flat, painted	Very Significant Qty:	
WN-12	Metal window, original (same profile as wood-grained) check on 8/16 or add new code	Very Significant Qty:	
W-19	white onyx travertine wall	Very Significant Qty:	
D-09	Wood slab door with decorative metal-wood grained casing, transom above	Contributory Qty:	
CPP-2	Gray Georgia marble post, hollow	Very Significant Qty:	
CR-2	Plaster cornice: crown molding, classical and simple	Very Significant Qty:	
D-07	Wood Panel door with decorative metal wood-grained casing	Significant Qty:

<b>F-1</b>	Gray Georgia marble floor, polished square	Very Significant Qty:
<b>B-1</b>	Gray marble base, 12" polished	Very Significant Qty:
<b>HC-10</b>	vent	Very Significant Qty:
<b>M-8</b>	Plaster ceiling medallion for chandelier	Very Significant Qty:
<b>ST-1</b>	Ornamental cast iron riser panel, painted	Significant Qty:

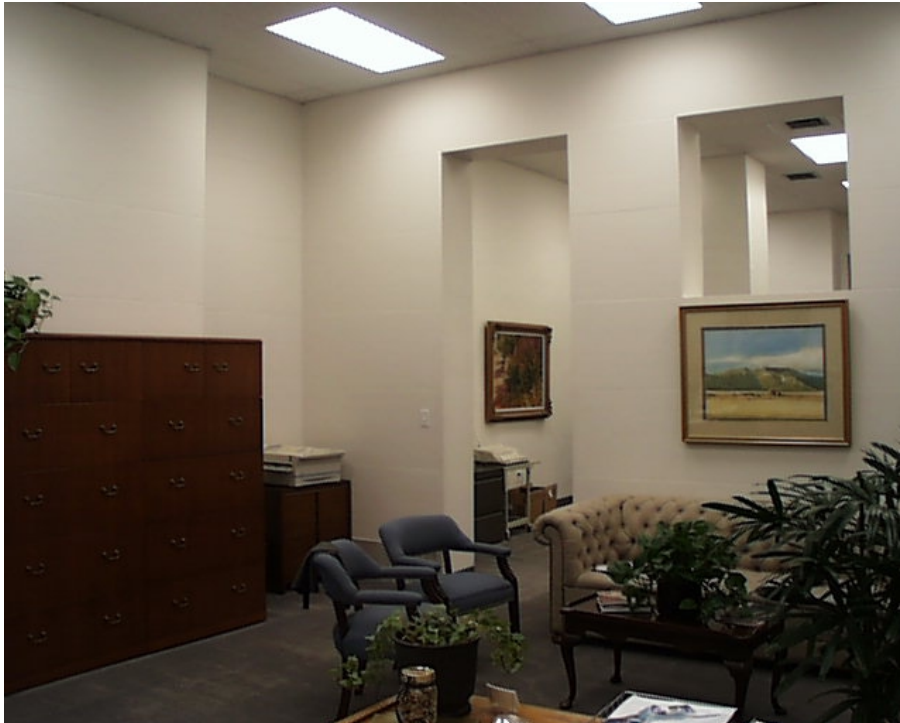
## Office of the First Lady

Notes Room 111 and 113 connect through an opening in the wall

Element	Description	Historical Significance	Notes
B-1	Gray marble base, 12" polished	Very Significant Qty:	
CL-08	Acoustical ceiling, suspended T-bar frame	Non-Contributory Qty:	
D-09	Wood slab door with decorative metal-wood grained casing, transom above	Contributory Qty:	H-3, but new handle Air vent above WN-11
F-12	Carpeted floor, glue-down	Non-Contributory Qty:	glue down, broadloom
L-08	Fluorescent lights	Non-Contributory Qty:	
W-2	Oolite slab wall, painted	Very Significant Qty:	All walls but 2 sections N. E. wall section on East wall and south east jutting corner on South wall
W-8	Sheetrock wall, painted and smooth	Contributory Qty:	small wall sections in room.
WN-1	Aluminum replacement window	Non-Contributory Qty:	typical throughout building

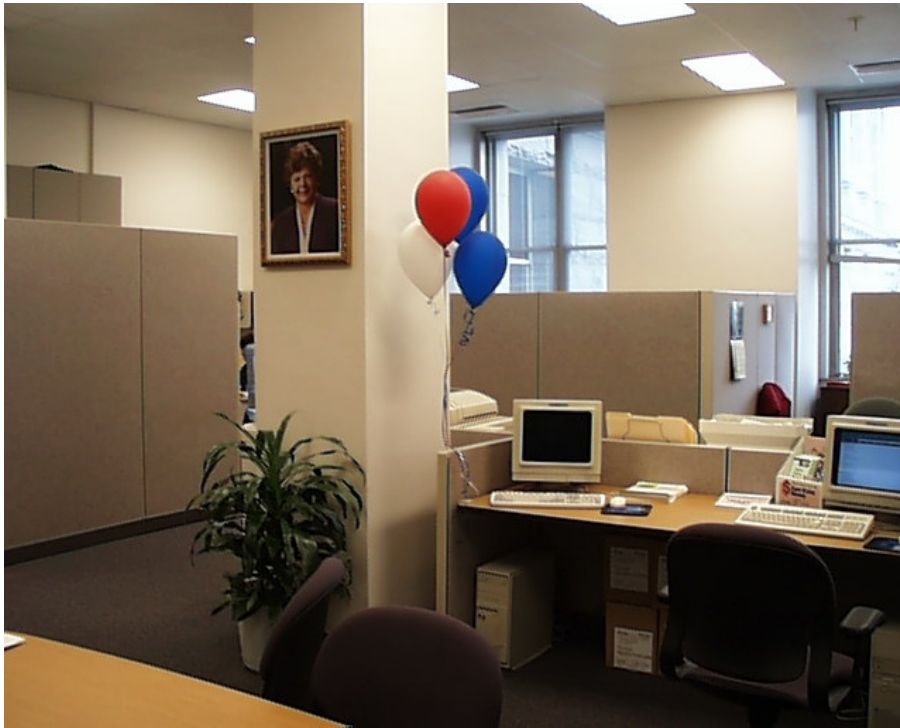
# 115 Elections Office

Notes All new Interiors, includes 115a,b,c  
Floor looks like it has a slope as it runs from the north side of the door to the wall. -  
There is a photo of this #??  
A 12'-8" x 10'-1"  
B 6'-10" x 10'-1"  
C 12'-2" x 10'-1"

Element	Description	Historical Significance	Notes
B-4	Rubber/vinyl base	Non-Contributory Qty:	
CL-08	Acoustical ceiling, suspended T-bar frame	Non-Contributory Qty:	
D-09	Wood slab door with decorative metal-wood grained casing, transom above	Contributory Qty:	This is the entry door - (note sloping towards wall.)
D-13	Metal wood-grained panel door with matching casing. Bankers glass panels	Contributory Qty:	New walls have new doors - note window transom above doors
F-12	Carpeted floor, glue-down	Non-Contributory Qty:	
HC-10	vent	Non-Contributory Qty:	air vent parallel to entry door
L-08	Fluorescent lights	Non-Contributory Qty:	
W-7	Plaster wall, painted and smooth	Contributory Qty:	Plaster walls don't surround - Noticed as the exterior walls and the east wall, north to the door placement only. This change marks the slopping.
W-8	Sheetrock wall, painted and smooth	Contributory Qty:	
WN-1	Aluminum replacement window	Contributory Qty: 4	Replacement windows - typical throughout building

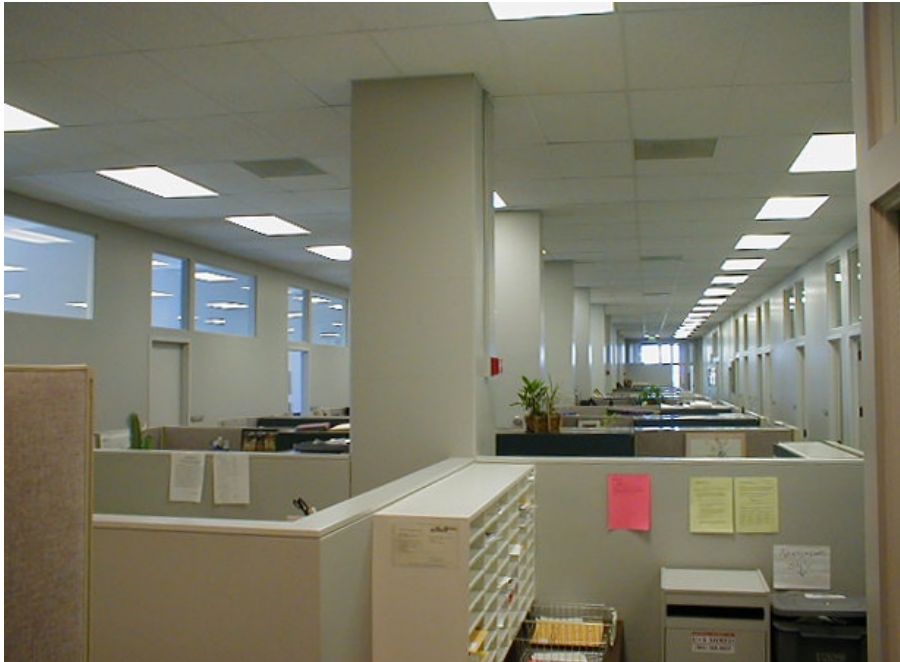
## G.O.P.B. Governor's Office of Planning and Budg

Notes Office is new - except around the west doors. The stairway and doors in that area appear to be original.

Element	Description	Historical Significance	Notes
B-1	Gray marble base, 12" polished	Very Significant Qty:	The marble base is only on some of the columns and original walls. Corner offices and the conference room have marble base on select sides.
B-4	Rubber/vinyl base	Non-Contributory Qty:	Rubber base over a plaster base in the exterior office rooms
CL-08	Acoustical ceiling, suspended T-bar frame	Non-Contributory Qty:	
D-09	Wood slab door with decorative metal-wood grained casing, transom above	Contributory Qty:	unsure if original or not- used as entry doors. Also - doors used as D-6 - but they have a wood pannel - closet doors/storage areas
D-13	Metal wood-grained panel door with matching casing. Bankers glass panels	Contributory Qty:	
F-12	Carpeted floor, glue-down	Contributory Qty:	
H-1	Brass door handle, modern	Contributory Qty:	
L-08	Fluorescent lights	Non-Contributory Qty:	
M-16	Marble window sill, original, with molded wood skirt	Non-Contributory Qty:

W-2	Oolite slab wall, painted	Very Significant Qty:	Used in the conference room - and select areas - mostly the diving wall between the office area and the public areas
W-7	Plaster wall, painted and smooth	Contributory Qty:	Original walls - not the dividing walls between exterior offices
WN-1	Aluminum replacement window	Non-Contributory Qty:	
WN-7	Wood transom	Contributory Qty:

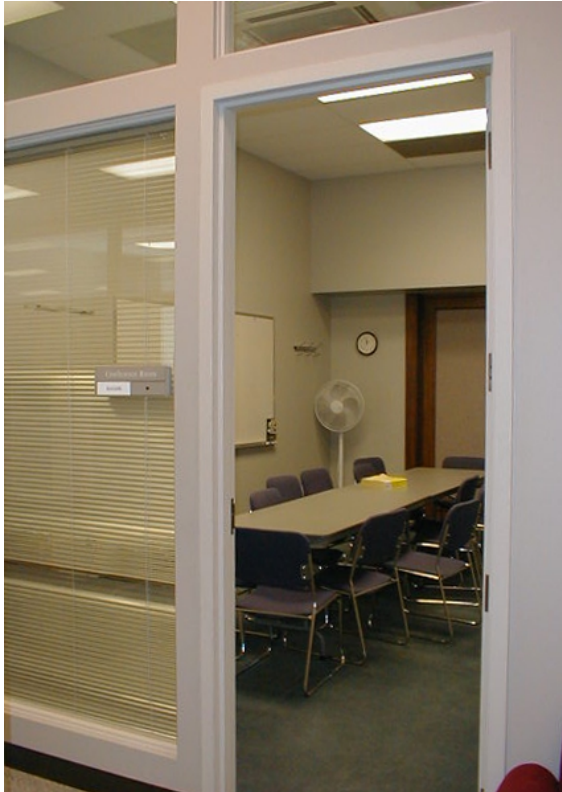
## 116a Conference Room

Notes Includes 165 thru 173.

Element	Description	Historical Significance	Notes
CL-08	Acoustical ceiling, suspended T-bar frame	Non-Contributory Qty:	
CL-09	Concrete ceiling	Contributory Qty:	
E-12	electrical box	Non Contributory Qty:	
F-12	Carpeted floor, glue-down	Contributory Qty:	
F-16	Concrete floor, painted	Non-Contributory Qty:	
L-08	Fluorescent lights	Non Contributory Qty:	
M-6	Metal wood-grained casing w/ fancy profile	Non-Contributory Qty:	
W-6	Concrete wall	Non-Contributory Qty:

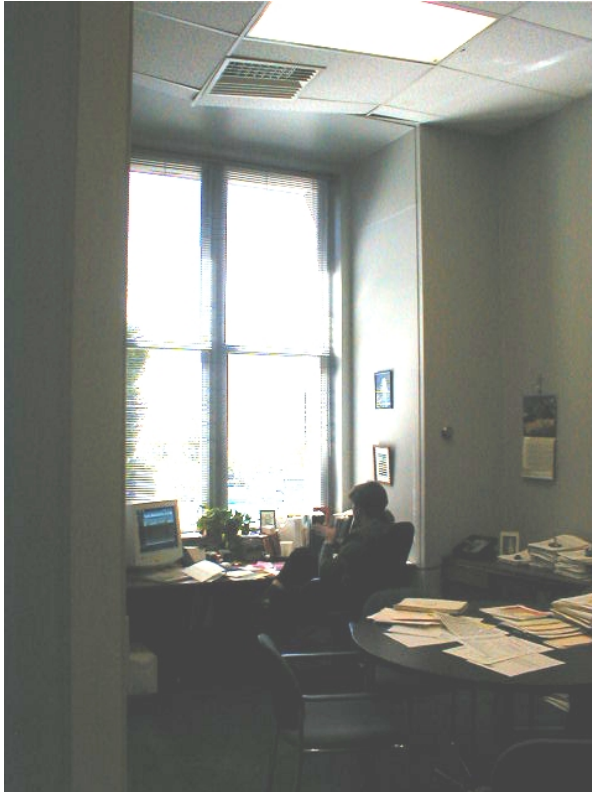
## G.O.P.B. Office

Element	Description	Historical Significance	Notes
B-1	Gray marble base, 12" polished	Very Significant Qty:	
B-4	Rubber/vinyl base	Non-Contributory Qty:	only on the new walls - b-1 on original walls
B-7	Marble base block	Significant Qty:	
CL-08	Acoustical ceiling, suspended T-bar frame	Non-Contributory Qty:	
D-09	Wood slab door with decorative metal-wood grained casing, transom above	Contributory Qty:	
F-14	Carpet tiles	Non-Contributory Qty:	
L-08	Fluorescent lights	Non-Contributory Qty:

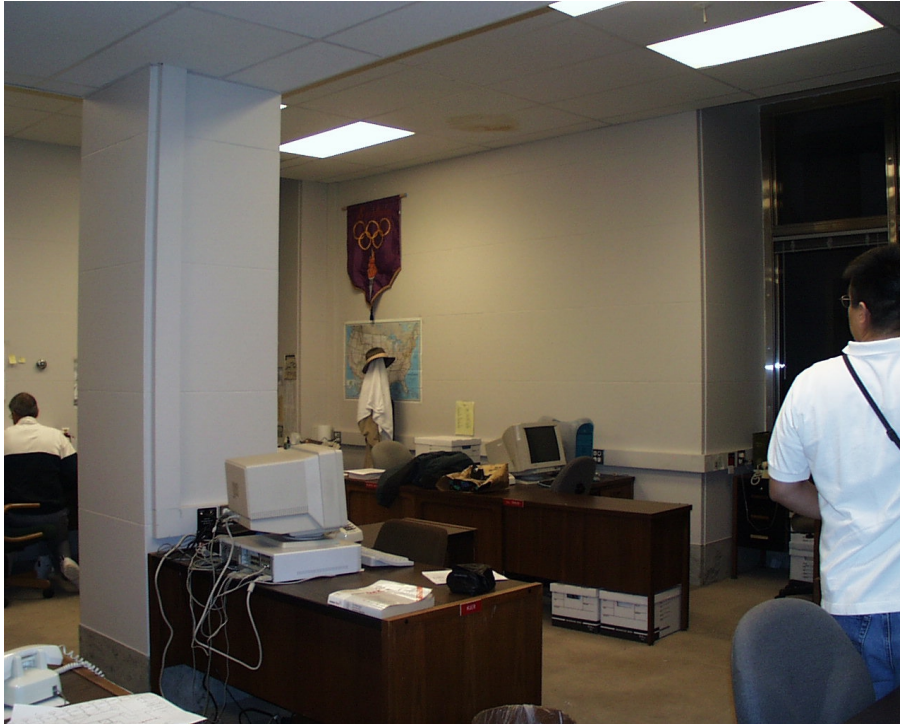
## Press Room 120/122

Notes Same room with two doors- different numbers. This room houses the press reporters with intercom ability to the legislature rooms

Element	Description	Historical Significance	Notes
F-7	Terrazzo floor, light green, with white and black specks	Non-Contributory Qty:	
B-1	Gray marble base, 12" polished	Very Significant Qty:	only along original walls
B-4	Rubber/vinyl base	Non-Contributory Qty:	
CL-08	Acoustical ceiling, suspended T-bar frame	Non-Contributory Qty:	Two ceiling levels, the lowest is probably dropped for electric wiring
CPP-4	Oolite column, painted	Significant Qty:	painted over/good condition, most likely original
D-09	Wood slab door with decorative metal-wood grained casing, transom above	Contributory Qty: 2	
F-14	Carpet tiles	Non-Contributory Qty:	
HC-10	vent	Non-Contributory Qty:	
HC-6	Thermostat	Non-Contributory Qty:	
L-08	Fluorescent lights	Non-Contributory Qty:	
M-6	Metal wood-grained casing w/ fancy profile	Contributory Qty:	
W-2	Oolite slab wall, painted	Very Significant Qty:	
W-7	Plaster wall, painted and smooth	Contributory Qty:

WN-1	Aluminum replacement window	Non-Contributory Qty:	
WN-11	Metal transom, louvered	Non-Contributory Qty:

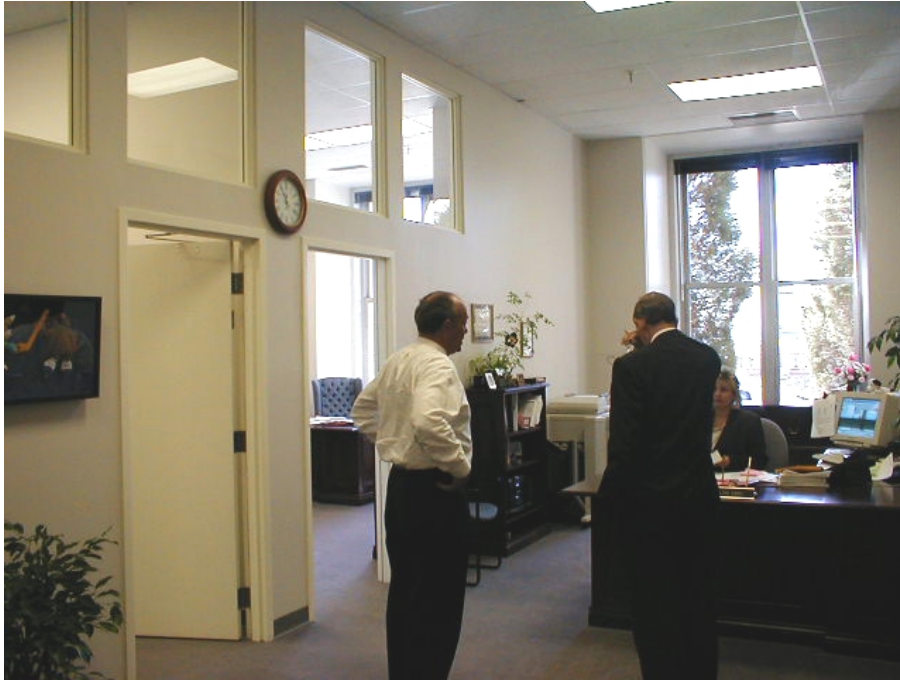
# 124 Olympic Committee

Notes includes 124 a - all new

Element	Description	Historical Significance	Notes
B-4	Rubber/vinyl base	Non-Contributory Qty:	
CL-08	Acoustical ceiling, suspended T-bar frame	Non-Contributory Qty:	possibility of original crown moulding CR-2 above
CPP-7	Plaster pilaster, painted	Significant Qty:	B-1 at window column (reception area) and at door. Middle column has B-4 new, with M-19
D-13	Metal wood-grained panel door with matching casing. Bankers glass panels	Contributory Qty:	
F-12	Carpeted floor, glue-down	Contributory Qty:	
L-08	Fluorescent lights	Non-Contributory Qty:	
M-16	Marble window sill, original, with molded wood skirt	Contributory Qty:	on WN-1
W-8	Sheetrock wall, painted and smooth	Contributory Qty:	
WN-1	Aluminum replacement window	Non-Contributory Qty: 2	with M-16

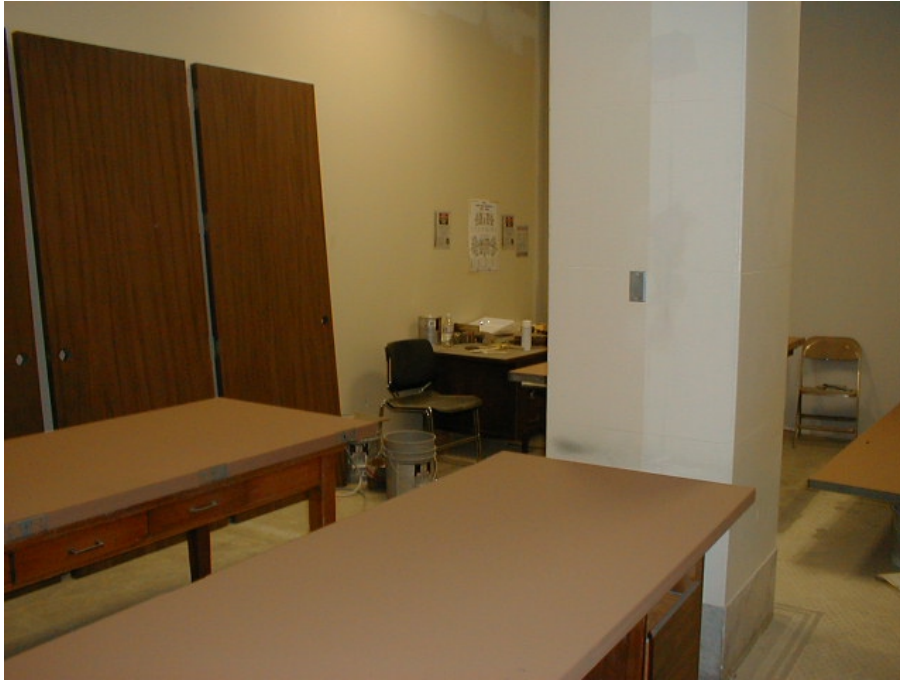
## 126 Vacant Offices Hall

Notes 126a thru 126i

Element	Description	Historical Significance	Notes
CL-06	Sheetrock ceiling, painted	Non-Contributory Qty:	in hall only
B-4	Rubber/vinyl base	Non-Contributory Qty:	
F-2	Tile floor, hex & square, mosaic	Significant Qty:	only in 126a, hex tile most probably runs under carpet in all rooms
L-08	Fluorescent lights	Non-Contributory Qty:	
M-19	Wood casing, new	Non-Contributory Qty:	on D-9
MS-3	Fire hose cabinet, glass, metal, recessed in wall	Non-Contributory Qty: 1	
CL-08	Acoustical ceiling, suspended T-bar frame	Non-Contributory Qty:	
CPP-5	Oolite pilaster, painted	Significant Qty:	with B-1
D-09	Wood slab door with decorative metal-wood grained casing, transom above	Contributory Qty:	With M-6
D-13	Metal wood-grained panel door with matching casing. Bankers glass panels	Contributory Qty:	With M-19
F-12	Carpeted floor, glue-down	Non-Contributory Qty:	
W-8	Sheetrock wall, painted and smooth	Contributory Qty:

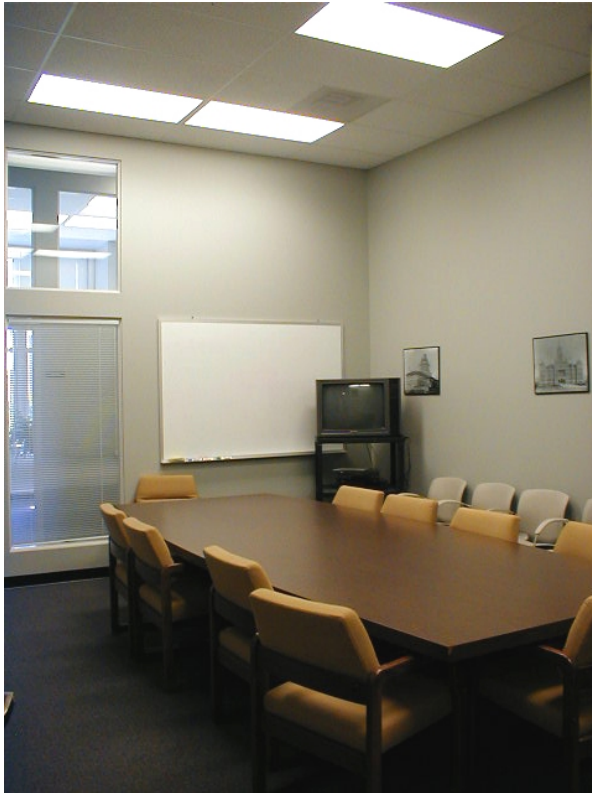
# 130f Legislative Auditor General Conference Room

**Notes** Room is new as of last year (1998-99) columns only original item. Haworth Systems throughout center area. Furniture in offices mostly new - some salvaged throughout the years. Most likely not original. Windows - only thing that could be considered contributory

Element	Description	Historical Significance	Notes
B-1	Gray marble base, 12" polished	Very Significant Qty:	mable base used on some columns. Very rare throughout office - there is some marble base in Wayne's office (front office - director)
B-4	Rubber/vinyl base	Non-Contributory Qty:	over the plaster base on the exterior walls
B-4	Rubber/vinyl base	Non-Contributory Qty:	
B-1	Gray marble base, 12" polished	Very Significant Qty:	
CL-08	Acoustical ceiling, suspended T-bar frame	Non-Contributory Qty:	
F-11	Carpeted floor, on pad	Contributory Qty:	
F-12	Carpeted floor, glue-down	Contributory Qty:	
L-08	Fluorescent lights	Non Contributory Qty:	
W-7	Plaster wall, painted and smooth	Contributory Qty:	
W-8	Sheetrock wall, painted and smooth	Contributory Qty:	
WN-1	Aluminum replacement window	Non Contributory Qty:	
WN-8	Interior sidelight window, metal	Non-Contributory Qty:

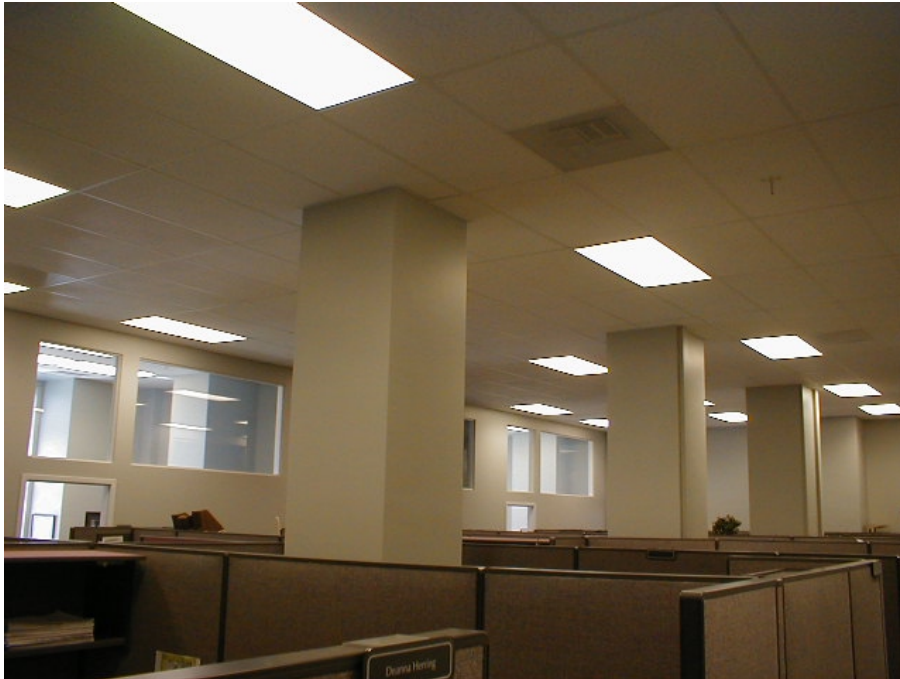
# 131 Legislative Auditor General

**Notes** Room is new as of last year (1998-99) columns only original item. Haworth Systems throughout center area. Furniture in offices mostly new - some salvaged throughout the years. Most likely not original. Windows - only thing that could be considered contributory

Element	Description	Historical Significance	Notes
B-1	Gray marble base, 12" polished	Very Significant Qty:	mable base used on some columns. Very rare throughout office - there is some marble base in Wayne's office (front office - director)
B-4	Rubber/vinyl base	Non-Contributory Qty:	over the plaster base on the exterior walls
CL-08	Acoustical ceiling, suspended T-bar frame	Non-Contributory Qty:	
F-11	Carpeted floor, on pad	Contributory Qty:	entry area and Wayne's Office
F-12	Carpeted floor, glue-down	Non-Contributory Qty:	throughout office space
L-08	Fluorescent lights	Non-Contributory Qty:	
W-7	Plaster wall, painted and smooth	Contributory Qty:	Exterior walls only
W-8	Sheetrock wall, painted and smooth	Contributory Qty:	
WN-1	Aluminum replacement window	Non-Contributory Qty:	
WN-8	Interior sidelight window, metal	Non-Contributory Qty:

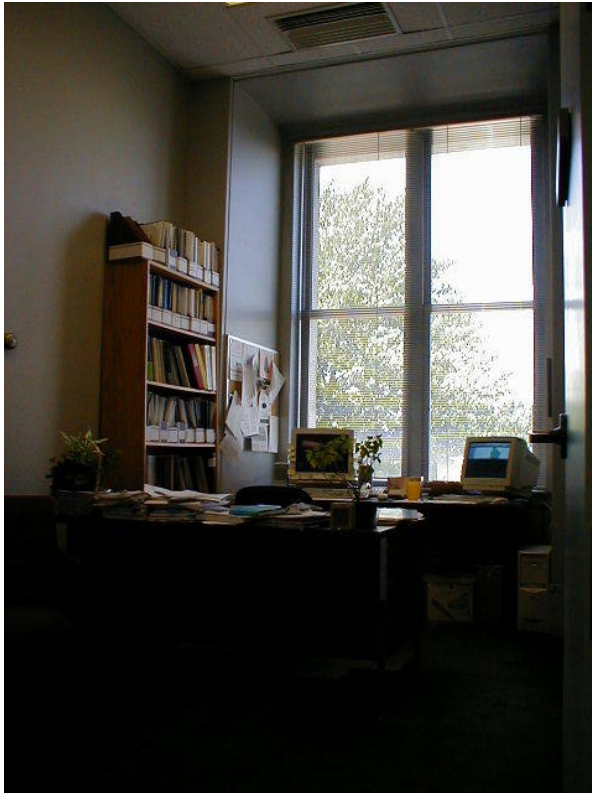
Element	Description	Historical Significance	Notes
B-4	Rubber/vinyl base	Non-Contributory Qty:	
WN-7	Wood transom	Contributory Qty:	
WN-1	Aluminum replacement window	Non Contributory Qty:	
W-7	Plaster wall, painted and smooth	Contributory Qty:	
W-2	Oolite slab wall, painted	Very Significant Qty:	
M-6	Metal wood-grained casing w/ fancy profile	Non-Contributory Qty:	
M-16	Marble window sill, original, with molded wood skirt	Contributory Qty:	
L-08	Fluorescent lights	Non Contributory Qty:	
H-1	Brass door handle, modern	Contributory Qty:	
F-12	Carpeted floor, glue-down	Contributory Qty:	
B-1	Gray marble base, 12" polished	Very Significant Qty:	
D-13	Metal wood-grained panel door with matching casing. Bankers glass panels	Contributory Qty:	
D-09	Wood slab door with decorative metal-wood grained casing, transom above	Contributory Qty:	
CL-08	Acoustical ceiling, suspended T-bar frame	Non-Contributory Qty:

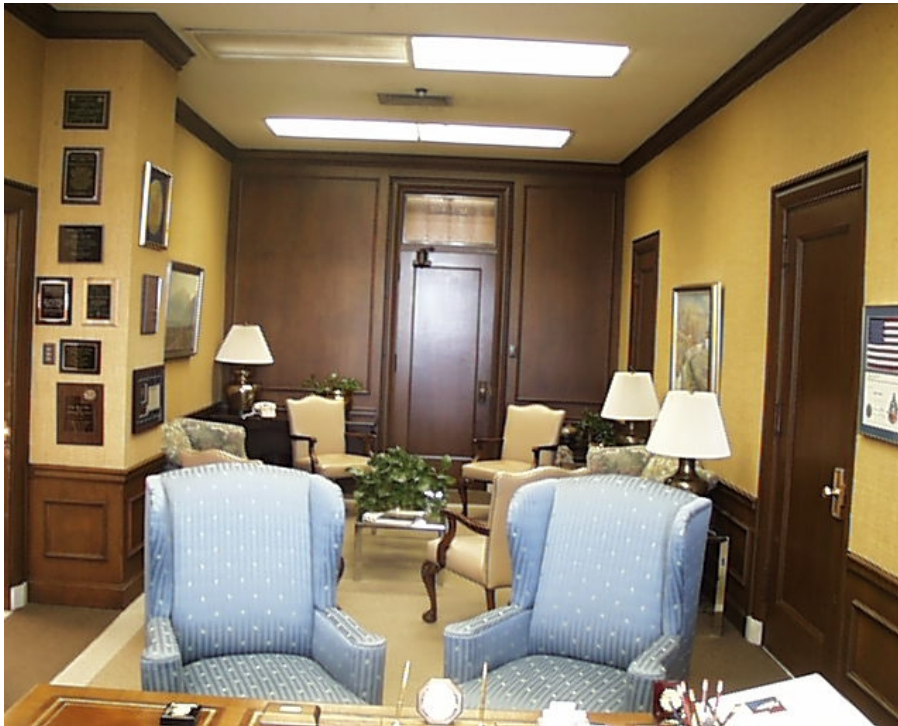
## 202 lieutenant Governor

Element	Description	Historical Significance	Notes
B-2	Molded wood base	Contributory Qty:	Part of the wainscot
B-7	Marble base block	Significant Qty: 4	At doors
CL-07	Acoustical tile ceiling, glue-on	Non-Contributory Qty:	
CR-5	Wood cornice	Non-Contributory Qty:	
D-05	Metal wood-grained panel door with matching casing	Significant Qty: 4	original, to room 203 with M-6
F-11	Carpeted floor, on pad	Contributory Qty:	custom padded with border
H-3	Brass door handle, old or original	Significant Qty: 3	on D-2
HC-10	vent	Non-Contributory Qty: 2	
HC-6	Thermostat	Non-Contributory Qty:	
L-08	Fluorescent lights	Non-Contributory Qty: 10	
M-6	Metal wood-grained casing w/ fancy profile	Non-Contributory Qty: 4	on D-2
W-11	Fabric wall, glue-on	Contributory Qty:	fabric, natural fiber
W-4	Wood panelled wall	Contributory Qty:	east, west walls
WN-1	Aluminum replacement window	Non-Contributory Qty: 2	with M-16
WS-3	Wood wainscot	Non-Contributory Qty:	not original

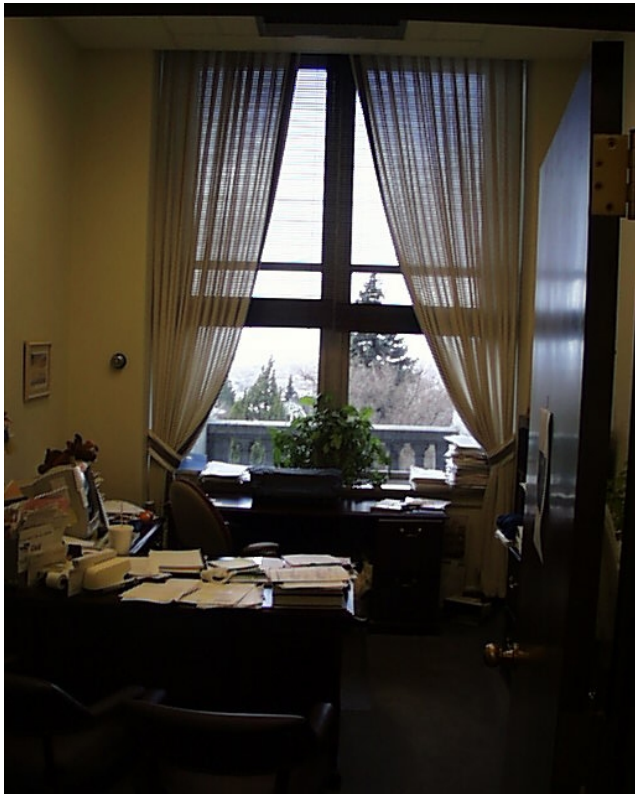
203

Element	Description	Historical Significance	Notes
B-6	Plaster base, painted	Very Significant Qty:	
B-4	Rubber/vinyl base	Non-Contributory Qty:	on top of wood B-6
CL-08	Acoustical ceiling, suspended T-bar frame	Non-Contributory Qty:	
D-13	Metal wood-grained panel door with matching casing. Bankers glass panels	Contributory Qty: 1	
F-11	Carpeted floor, on pad	Contributory Qty:	
HC-10	vent	Non-Contributory Qty: 1	
L-08	Fluorescent lights	Non-Contributory Qty: 4	
W-18	demountable wall	Non-Contributory Qty:	
W-7	Plaster wall, painted and smooth	Contributory Qty:	
WN-1	Aluminum replacement window	Non-Contributory Qty: 2

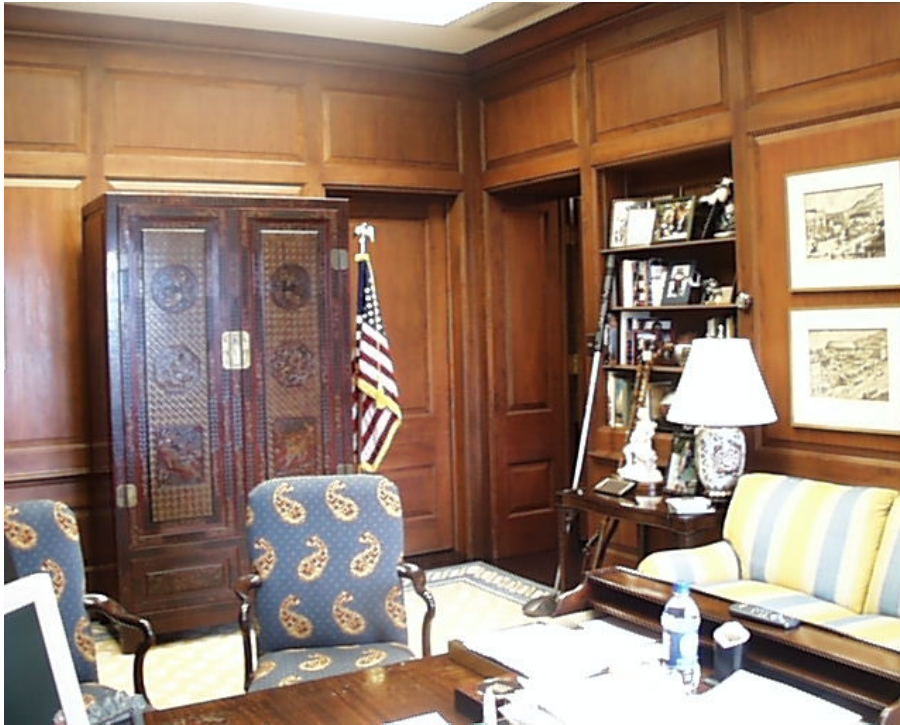
## 204

Element	Description	Historical Significance	Notes
SP-18	drapery	Contributory Qty:	
SP-3	Wood bookcase, built-in	Contributory Qty:	
B-2	Molded wood base	Contributory Qty:	part of wood paneled wall
CL-07	Acoustical tile ceiling, glue-on	Non-Contributory Qty:	
CR-5	Wood cornice	Non-Contributory Qty:	part of wood paneled wall
D-19	Wood slab door with plain metal casing. (demountable wall doors)	Contributory Qty: 1	new, with M-19
F-15	Floor rug/carpet	Non-Contributory Qty:	Carpet
F-3	Original wood floor: maple	Very Significant Qty:	Dark Mahogany Finish, probably oak
HC-10	vent	Non-Contributory Qty: 2	
HC-14	Return vent	Non-Contributory Qty: 1	
HC-16	wood-paneled duct/vent in window sill	Non-Contributory Qty: 2	
HC-6	Thermostat	Non-Contributory Qty: 3	
L-08	Fluorescent lights	Non-Contributory Qty: 6	Difused Screen
M-11	Wood chair rail	Non-Contributory Qty:	part of wood paneled wall
SP-9	Furniture now HF	Significant Qty:	federal 2-sided desk: original?

<b>W-4</b>	Wood panelled wall	Non-Contributory Qty:
<b>WN-1</b>	Aluminum replacement window	Non-Contributory Qty: 2

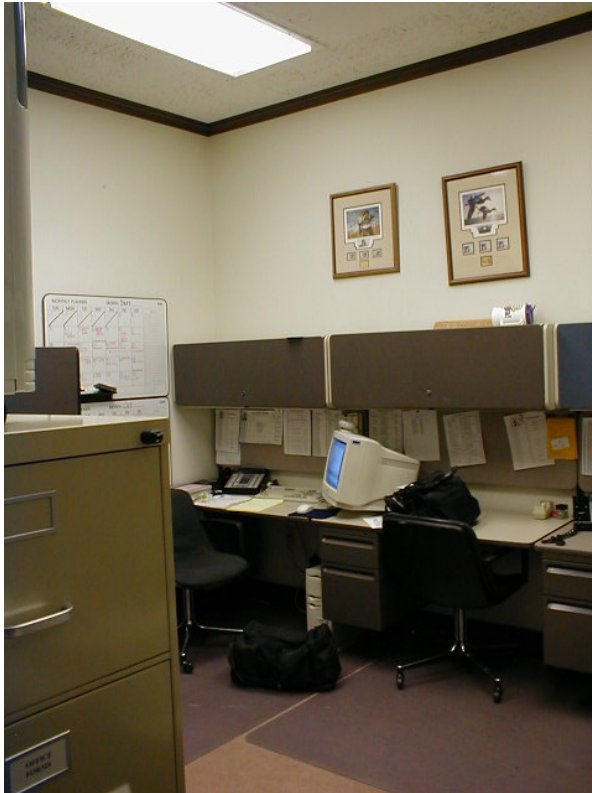
## 204a Governor's Security Office

Notes originally part of board room

Element	Description	Historical Significance	Notes
B-6	Plaster base, painted	Contributory Qty:	stained
CL-12	Plaster ceiling with stenciling	Significant Qty:	beige with gold egg & dart, above acoustic ceiling
CL-07	Acoustical tile ceiling, glue-on	Non-Contributory Qty:	ceiling lowered 3'-2 3/4" from original ceiling
CR-2	Plaster cornice: crown molding, classical and simple	Significant Qty:	same as board room, 12" tall, 11" protrusion above acoustic ceiling
CR-5	Wood cornice	Non-Contributory Qty:	
CR-7	Ornamental band: stenciled panel beneath cornice	Very Significant Qty:	same as board room, 95% intact - above acoustic ceiling
D-27	Wood slab door with etched panel look. Plain wood casing, extending up to 1/2 transom. Governor's area specific	Contributory Qty: 1	
E-12	electrical box	Non Contributory Qty:	insufficient electric capacity
F-11	Carpeted floor, on pad	Contributory Qty:	
L-08	Fluorescent lights	Non-Contributory Qty: 4	difused screens

W-7	Plaster wall, painted and smooth	Contributory Qty:	
WN-9	Leaded glass window, interior	Significant Qty: 1

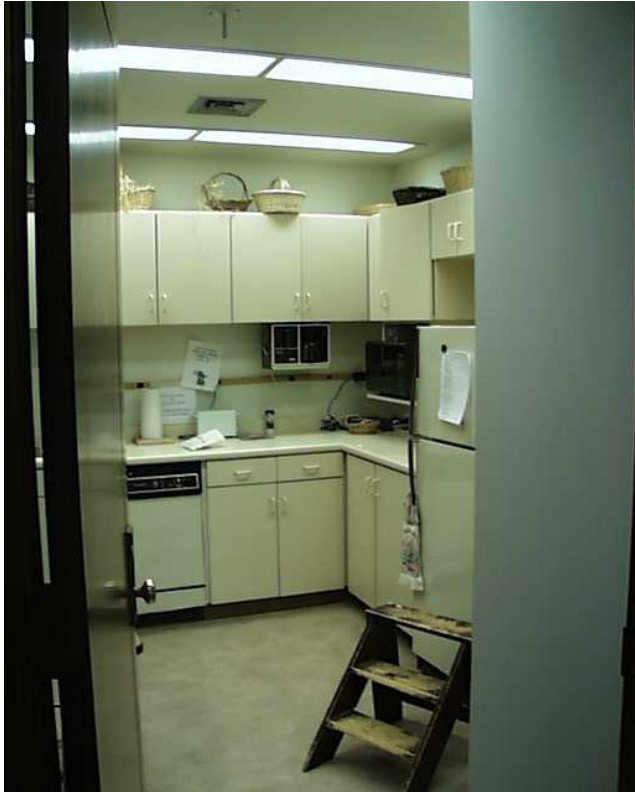
## 206a Kitchen - Governor's Area

Element	Description	Historical Significance	Notes
F-1	Gray Georgia marble floor, polished square	Significant Qty:	
B-4	Rubber/vinyl base	Non Contributory Qty:	
WS-8	Tile wainscot	Non Contributory Qty:	
D-15	Wood slab door with plain wood casing (simple closet/demountable doors)	Contributory Qty: 2	with M-19
E-12	electrical box	Non-Contributory Qty: 3	
HC-14	Return vent	Non-Contributory Qty: 1	
L-08	Fluorescent lights	Non-Contributory Qty: 6	
P-6	Metal sink	Non-Contributory Qty:	kitchen sink, refrigerator, dishwasher
W-8	Sheetrock wall, painted and smooth	Contributory Qty:	
B-4	Rubber/vinyl base	Non-Contributory Qty:	
CL-06	Sheetrock ceiling, painted	Non-Contributory Qty:	
F-9	Linoleum floor	Non-Contributory Qty:

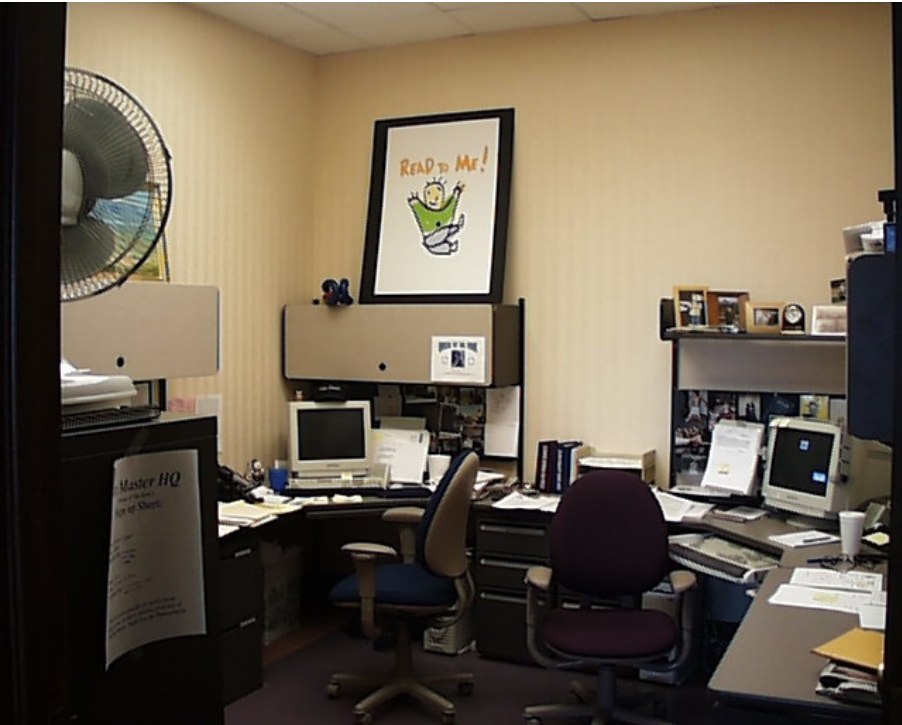
209b

Element	Description	Historical Significance	Notes
B-6	Plaster base, painted	Contributory Qty:	Stain
CL-08	Acoustical ceiling, suspended T-bar frame	Non-Contributory Qty:	
CPP-7	Plaster pilaster, painted	Significant Qty:	wallpapered
D-27	Wood slab door with etched panel look. Plain wood casing, extending up to 1/2 transom. Governor's area specific	Contributory Qty:	
F-11	Carpeted floor, on pad	Contributory Qty:	
L-08	Fluorescent lights	Non-Contributory Qty: 4	
M-19	Wood casing, new	Non-Contributory Qty:	
W-14	Wallpapered wall	Non-Contributory Qty:	vinyl

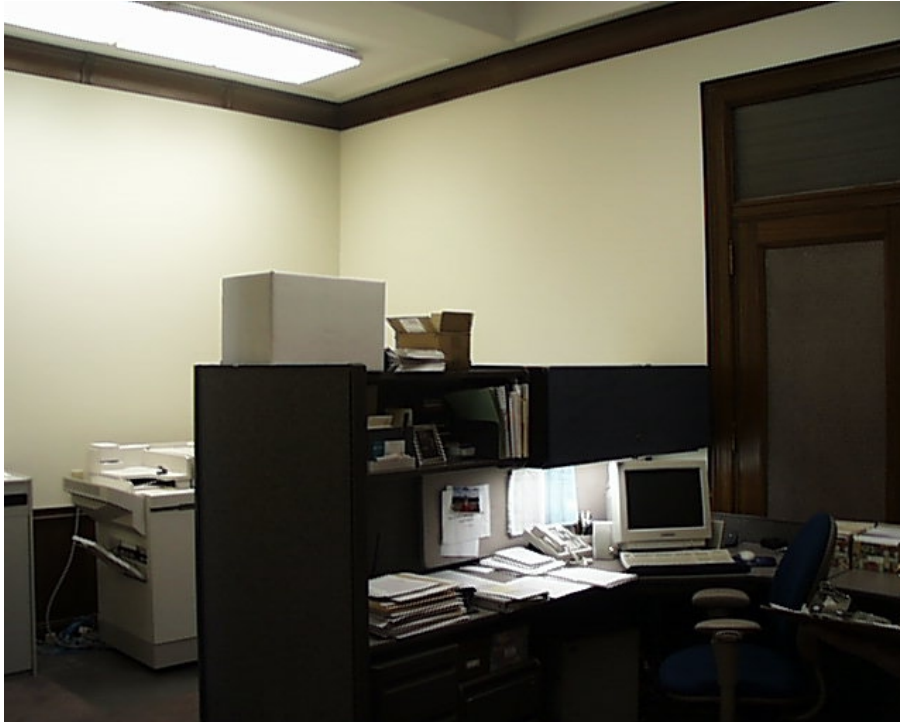
## 209c (Governor's Area) Office

Element	Description	Historical Significance	Notes
B-6	Plaster base, painted	Contributory Qty:	Stain
D-27	Wood slab door with etched panel look. Plain wood casing, extending up to 1/2 transom. Governor's area specific	Contributory Qty: 1	
D-10	Metal wood-grained panel door with matching casing. Bankers glass panel and transom	Very Significant Qty:	Double to main corridor
F-11	Carpeted floor, on pad	Contributory Qty:	
D-19	Wood slab door with plain metal casing. (demountable wall doors)	Significant Qty:	Door to Gold room - the casing is part of the wood paneling about 20" x 20"
L-08	Fluorescent lights	Non-Contributory Qty: 10	
W-4	Wood panelled wall	Non-Contributory Qty:	East Wall
W-8	Sheetrock wall, painted and smooth	Contributory Qty:	
CL-05	Coffered plaster ceiling, beams, ornamental, with molding	Contributory Qty:	
W-7	Plaster wall, painted and smooth	Very Significant Qty:	
WS-4	Oak wainscot	Contributory Qty:

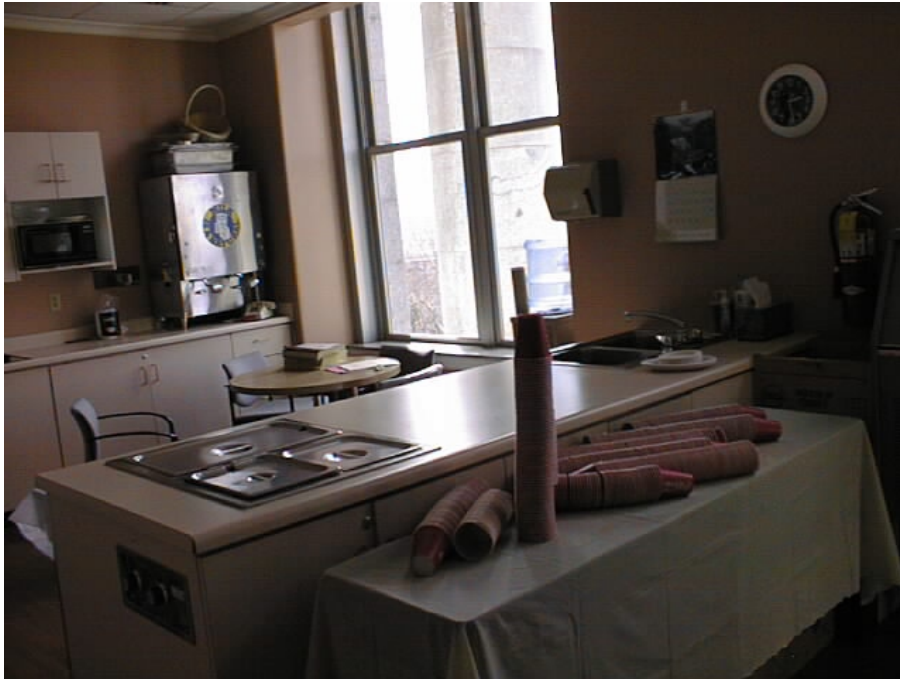
301

Element	Description	Historical Significance	Notes
D-25	Wood panel door with decorative wood casing	Non Contributory Qty:	Double door to storage closet, and 2 single doors for entrance with marble thresholds
M-11	Wood chair rail	Non Contributory Qty:	
SP-5	Built-in cabinet	Non Contributory Qty:	
SP-6	Built-in counter top	Non Contributory Qty:	
B-2	Molded wood base	Contributory Qty:	Stained
CL-08	Acoustical ceiling, suspended T-bar frame	Non-Contributory Qty:	
D-05	Metal wood-grained panel door with matching casing	Contributory Qty:	
F-10	Vinyl floor	Non Contributory Qty:	Possibly - Wood like, (Pergo?)
L-81	Parabolic	Non Contributory Qty:	
W-8	Sheetrock wall, painted and smooth	Contributory Qty:	
WN-1	Aluminum replacement window	Non Contributory Qty:

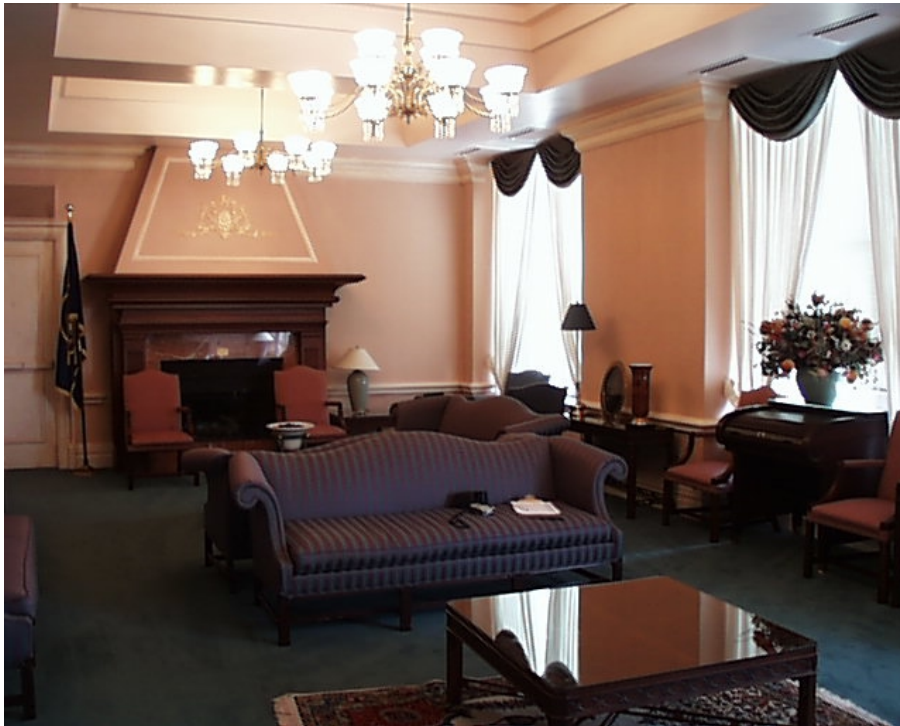
## House of Representatives Private Lounge

Element	Description	Historical Significance	Notes
F-11	Carpeted floor, on pad	Contributory Qty:	
B-2	Molded wood base	Contributory Qty:	Painted - Antiqued - Pink/white
W-7	Plaster wall, painted and smooth	Very Significant Qty:	
W-11	Fabric wall, glue-on	Non Contributory Qty:	
M-11	Wood chair rail	Non Contributory Qty:	
CR-2	Plaster cornice: crown molding, classical and simple	Contributory Qty:	
CL-14	Modern coffered ceiling, in four stages	Non Contributory Qty:	
HC-10	vent	Significant Qty:	
SP-18	drapery	Contributory Qty:	
WN-1	Aluminum replacement window	Contributory Qty:	no skirts
FP-4	Sheetrock fireplace hood, hollow with plaster ornament	Contributory Qty: 2	and entire fireplace
D-11	Metal wood-grained panel door with matching casing. Plain louver transom	Contributory Qty:	either end / North and South
D-05	Metal wood-grained panel door with matching casing	Very Significant Qty:	to chamber - taller 10'

L-25	Modern brass "antiqued" chandeliers, 8 arms	Significant Qty:

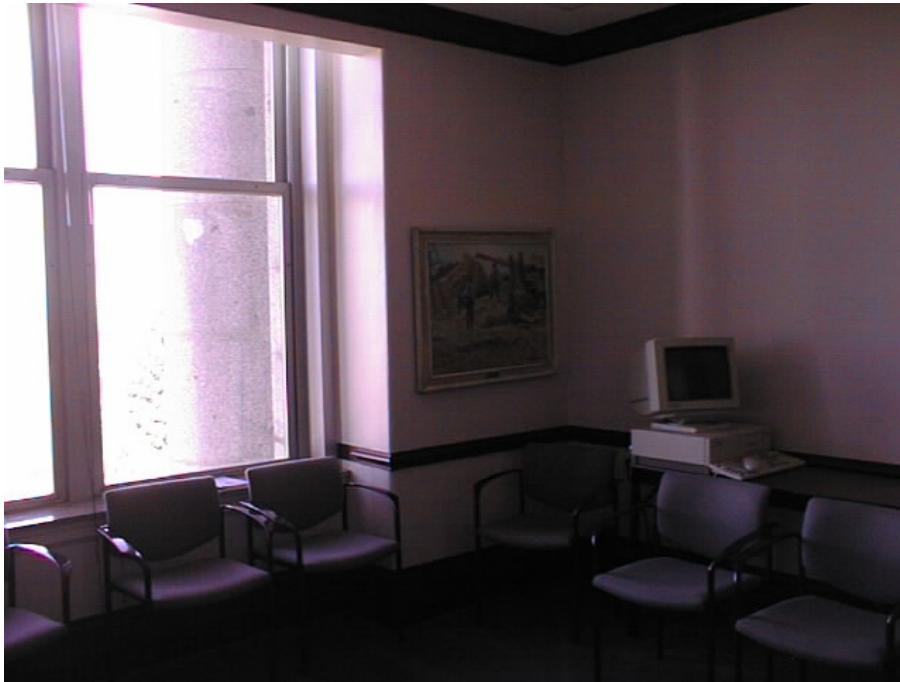
## 306 Conference Room

Notes same as 304 with minor exceptions

Element	Description	Historical Significance	Notes
M-11	Wood chair rail	Non-Contributory Qty:	
W-7	Plaster wall, painted and smooth	Contributory Qty:	
CR-5	Wood cornice	Contributory Qty:	
CL-08	Acoustical ceiling, suspended T-bar frame	Non-Contributory Qty:	
L-81	Parabolic	Non Contributory Qty:	
WN-1	Aluminum replacement window	Non Contributory Qty:	
B-2	Molded wood base	Contributory Qty:

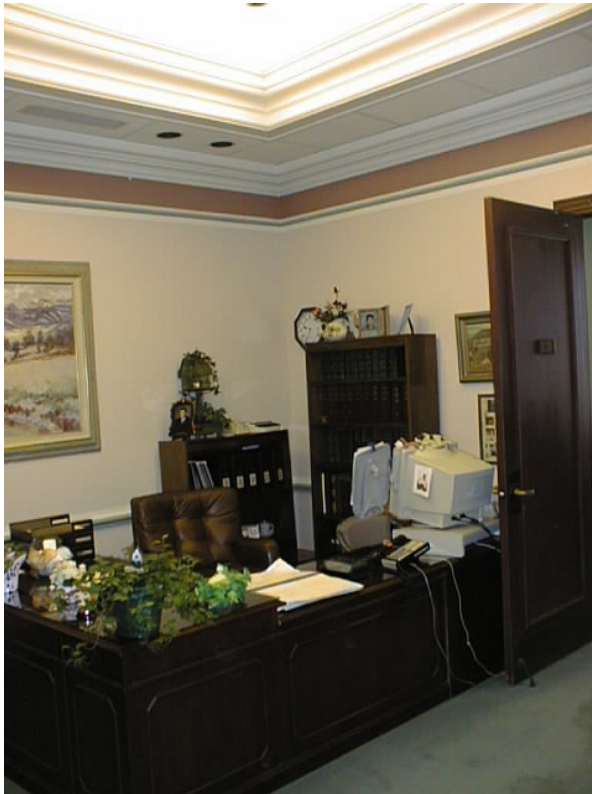
318

Notes Filing cabinets are recessed into the wall area/alcove (7-8 cabinets)

Element	Description	Historical Significance	Notes
MS-3	Fire hose cabinet, glass, metal, recessed in wall	Significant Qty:	
L-81	Parabolic	Non Contributory Qty:	
L-14	Recessed lights	Non Contributory Qty:	
B-2	Molded wood base	Contributory Qty:	painted
CL-06	Sheetrock ceiling, painted	Non-Contributory Qty:	
CL-08	Acoustical ceiling, suspended T-bar frame	Non-Contributory Qty:	
CR-2	Plaster cornice: crown molding, classical and simple	Contributory Qty:	
D-12	Metal wood-grained panel door with matching casing. Decorative louver transom	Contributory Qty:	Main Entry, with marble threshold
D-25	Wood panel door with decorative wood casing	Contributory Qty: 2	To hall and offices
F-11	Carpeted floor, on pad	Contributory Qty:	
L-12	Indirect cove lighting	Non-Contributory Qty:	
L-14	Recessed lights	Non-Contributory Qty:	
M-11	Wood chair rail	Non-Contributory Qty:	Painted
M-12	Wood picture rail	Non-Contributory Qty:	Part of Cornice

W-8	Sheetrock wall, painted and smooth	Contributory Qty:

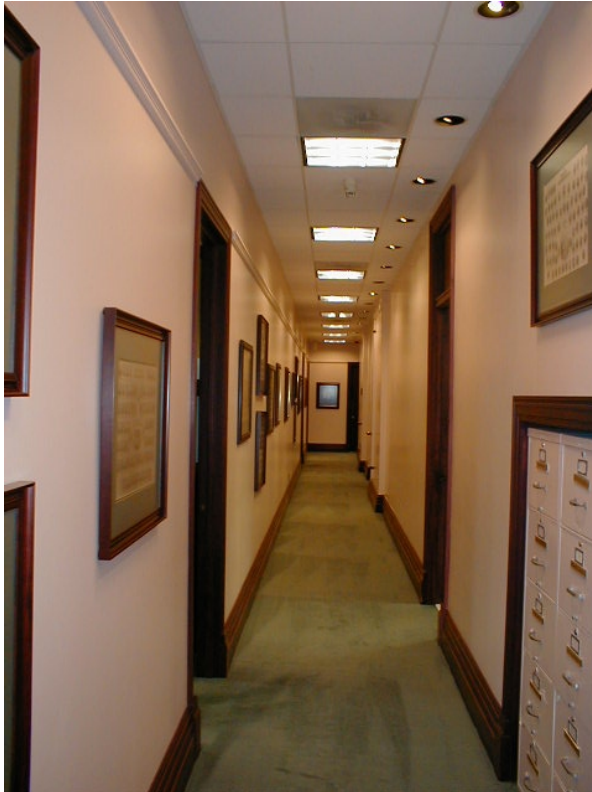
## 318a House of Representatives Offices

Element	Description	Historical Significance	Notes
D-11	Metal wood-grained panel door with matching casing. Plain louver transom	Contributory Qty:	
F-12	Carpeted floor, glue-down	Contributory Qty:	
L-14	Recessed lights	Non Contributory Qty:	
CL-08	Acoustical ceiling, suspended T-bar frame	Non-Contributory Qty:	
W-8	Sheetrock wall, painted and smooth	Contributory Qty:	
L-81	Parabolic	Non Contributory Qty:

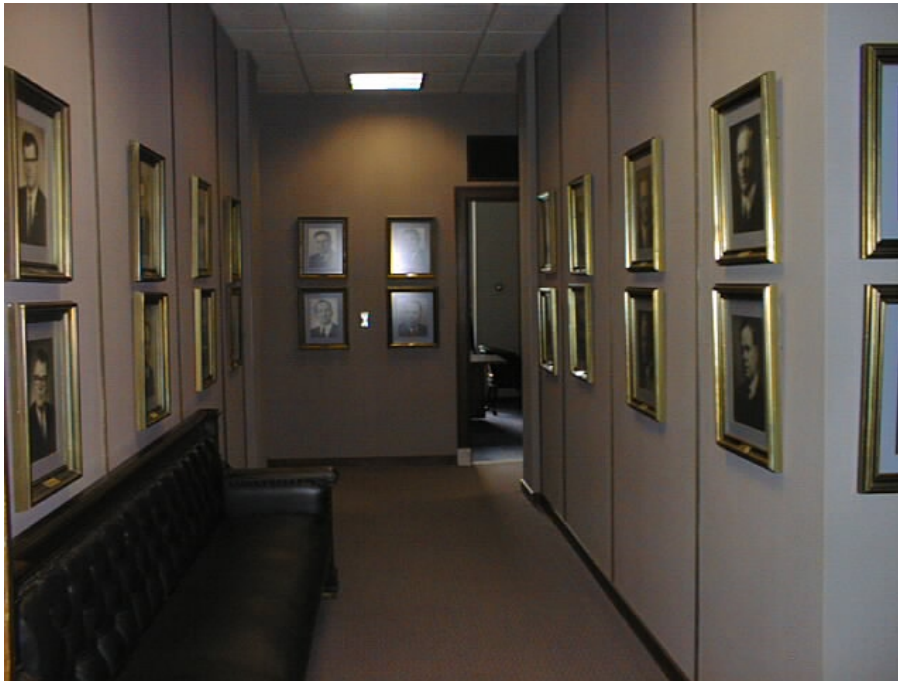
## 319 Senate Office Hall

Element	Description	Historical Significance	Notes
D-04	Wood panel door, decorative metal wood-grained casing, transom above	Very Significant Qty:	Door to chamber - with marble base block
D-14	Metal wood-grained panel door with decorative wood casing. Bankers glass panels	Non Contributory Qty:	door to 361 (Presidents office) with marbloe base block
D-14	Metal wood-grained panel door with decorative wood casing. Bankers glass panels	Non Contributory Qty:	Wire glass, marble base block/ 2 side lights - wood casing and wire glass
M-19	Wood casing, new	Significant Qty:	Double entry - no door panels/slabs
F-12	Carpeted floor, glue-down	Contributory Qty:	Carpeted floor, not glue down
M-19	Wood casing, new	Non Contributory Qty:	with B-7
WN-1	Aluminum replacement window	Non Contributory Qty: 1 pr	with M-16
B-2	Molded wood base	Contributory Qty:	Stain
B-7	Marble base block	Significant Qty:	at all door casings, at storage and HS

CL-08	Acoustical ceiling, suspended T-bar frame	Non Contributory Qty:	
D-07	Wood Panel door with decorative metal wood-grained casing	Significant Qty: 2	Also to small closets/ with marble base block.
D-12	Metal wood-grained panel door with matching casing. Decorative louver transom	Very Significant Qty: 1	ceiling lowered to cover transom
HC-7	Duct	Non Contributory Qty:	south
HF-3		Very Significant Qty: 1	matching Senate chamber benches

L-14	Recessed lights	Non Contributory Qty:	above coat area and hall side
L-81	Parabolic	Non Contributory Qty:	
W-11	Fabric wall, glue-on	Contributory Qty:	vinyl with wood trim

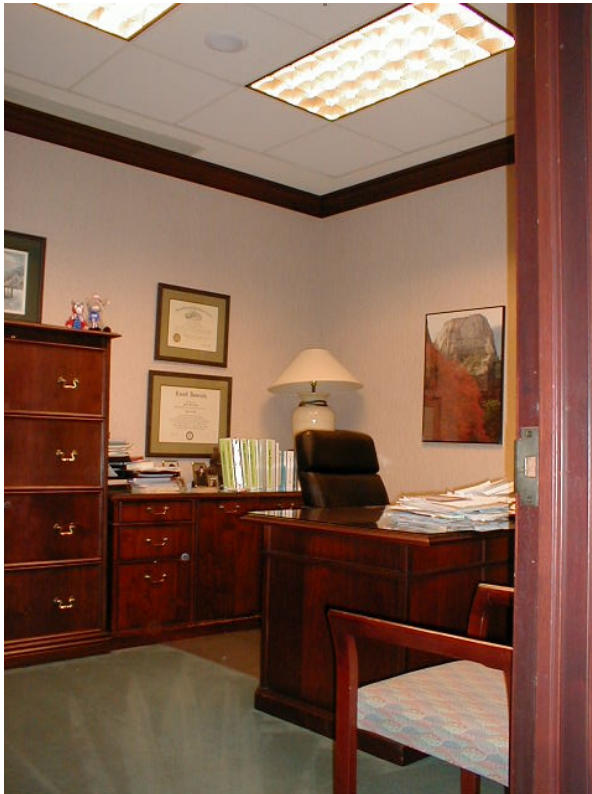
## 320 Assistant Minority Whip

Element	Description	Historical Significance	Notes
W-8	Sheetrock wall, painted and smooth	Contributory Qty:	
W-7	Plaster wall, painted and smooth	Very Significant Qty:	
D-04	Wood panel door, decorative metal wood-grained casing, transom above	Contributory Qty:	
W-13	Wallpapered wall, bookcloth/burlap	Contributory Qty:	vinyl wall covering
L-81	Parabolic	Non Contributory Qty:	
CL-08	Acoustical ceiling, suspended T-bar frame	Non-Contributory Qty:	
CR-5	Wood cornice	Contributory Qty:	
F-11	Carpeted floor, on pad	Contributory Qty:	
B-2	Molded wood base	Contributory Qty:	
CL-06	Sheetrock ceiling, painted	Non-Contributory Qty:

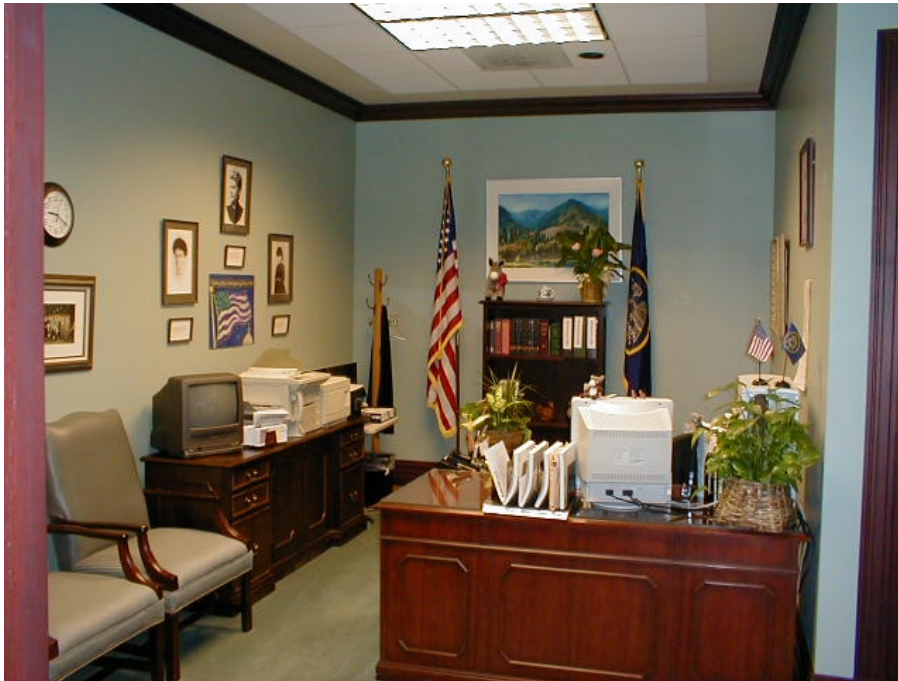
## 320a Secretary to Minority Whip]

Element	Description	Historical Significance	Notes
W-8	Sheetrock wall, painted and smooth	Contributory Qty:	
B-2	Molded wood base	Contributory Qty:	1' base, stained
CL-06	Sheetrock ceiling, painted	Non-Contributory Qty:	
CL-08	Acoustical ceiling, suspended T-bar frame	Non-Contributory Qty:	
CR-5	Wood cornice	Contributory Qty:	
D-25	Wood panel door with decorative wood casing	Contributory Qty:	
F-11	Carpeted floor, on pad	Contributory Qty:	
L-81	Parabolic	Non Contributory Qty:	
L-14	Recessed lights	Non Contributory Qty:
